Situation Photo Log

Thursday, May 10, 2012

Kalamazoo River / Enbridge Spill

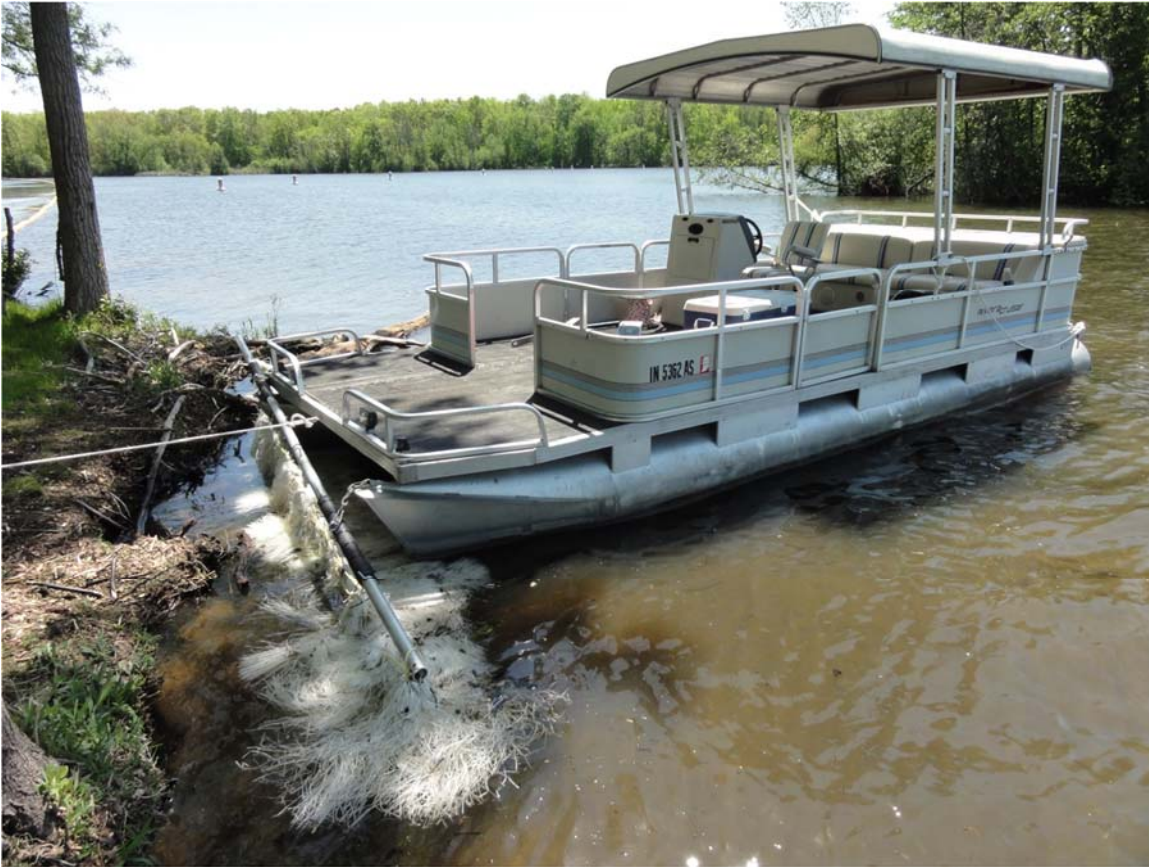
1. Pontoon sweep boat docked at E4.

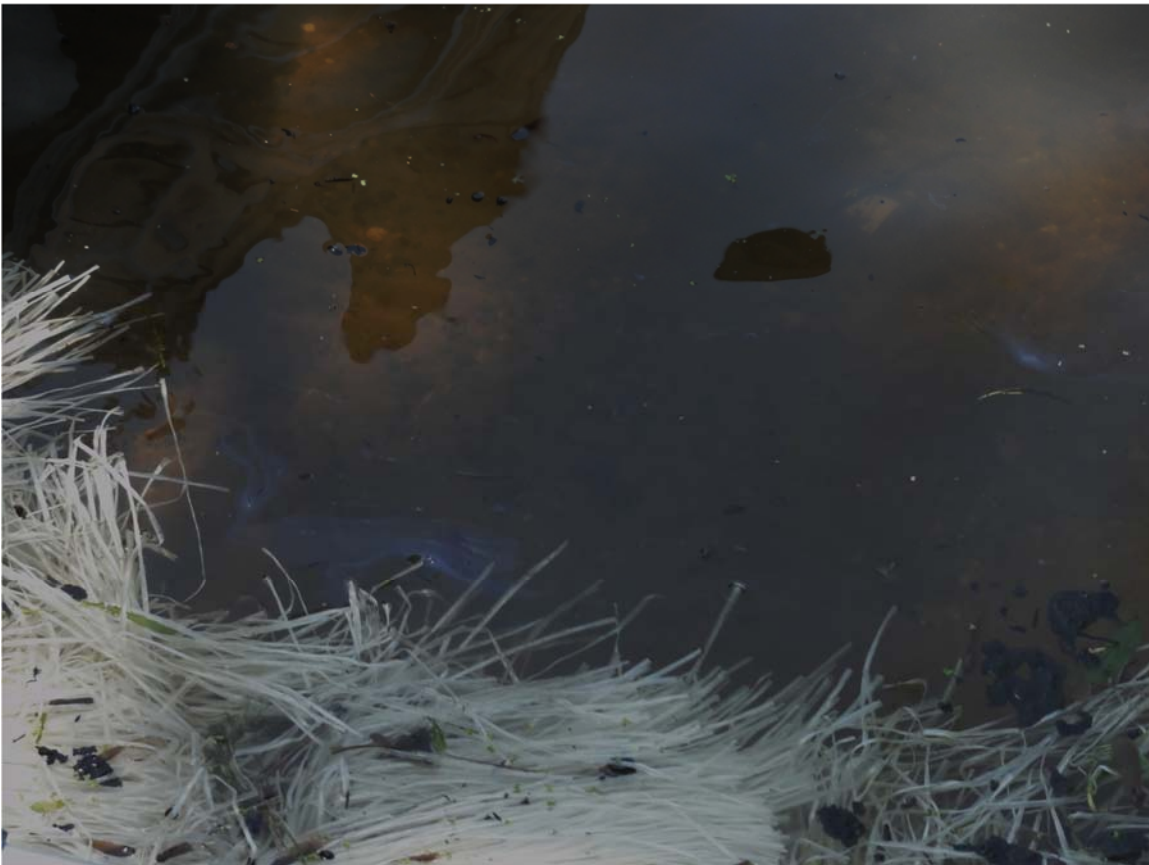
2. Sheen observed around pom poms of sweep boat docked at E4.

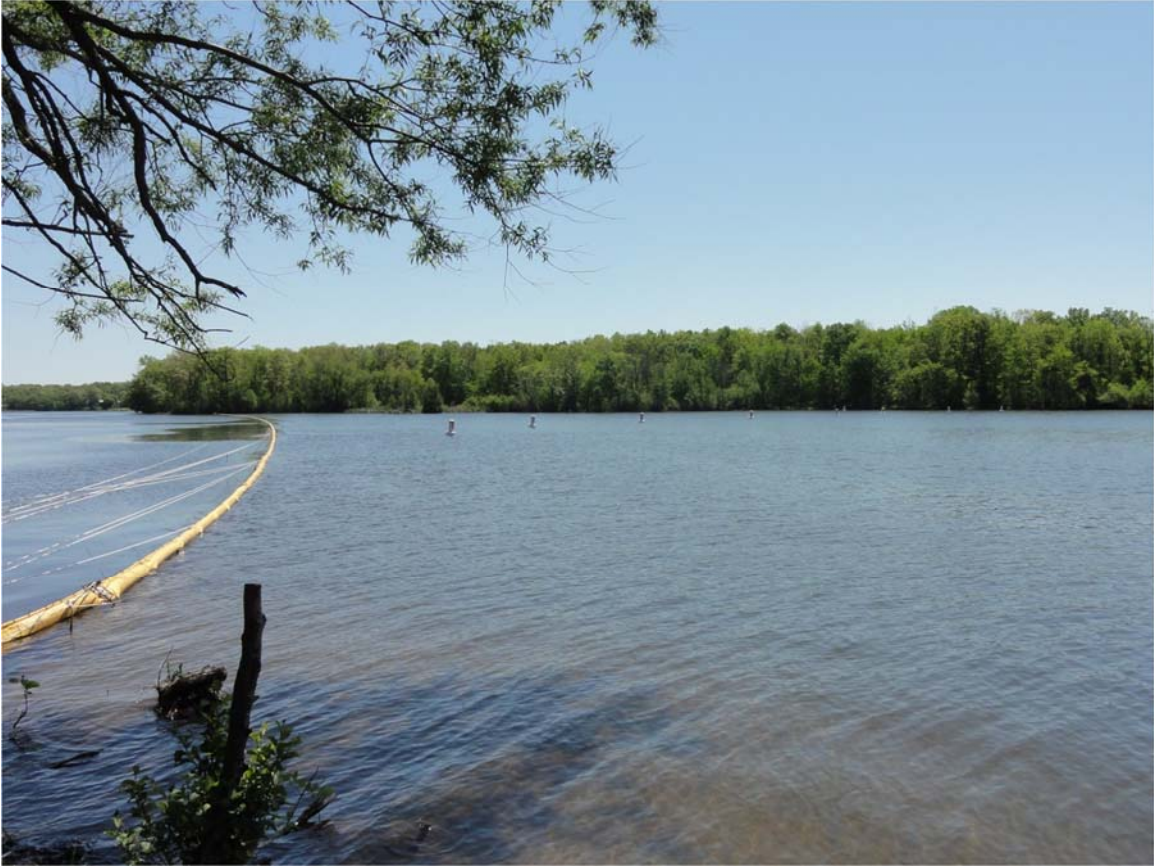
3. Can buoys deployed at E4.

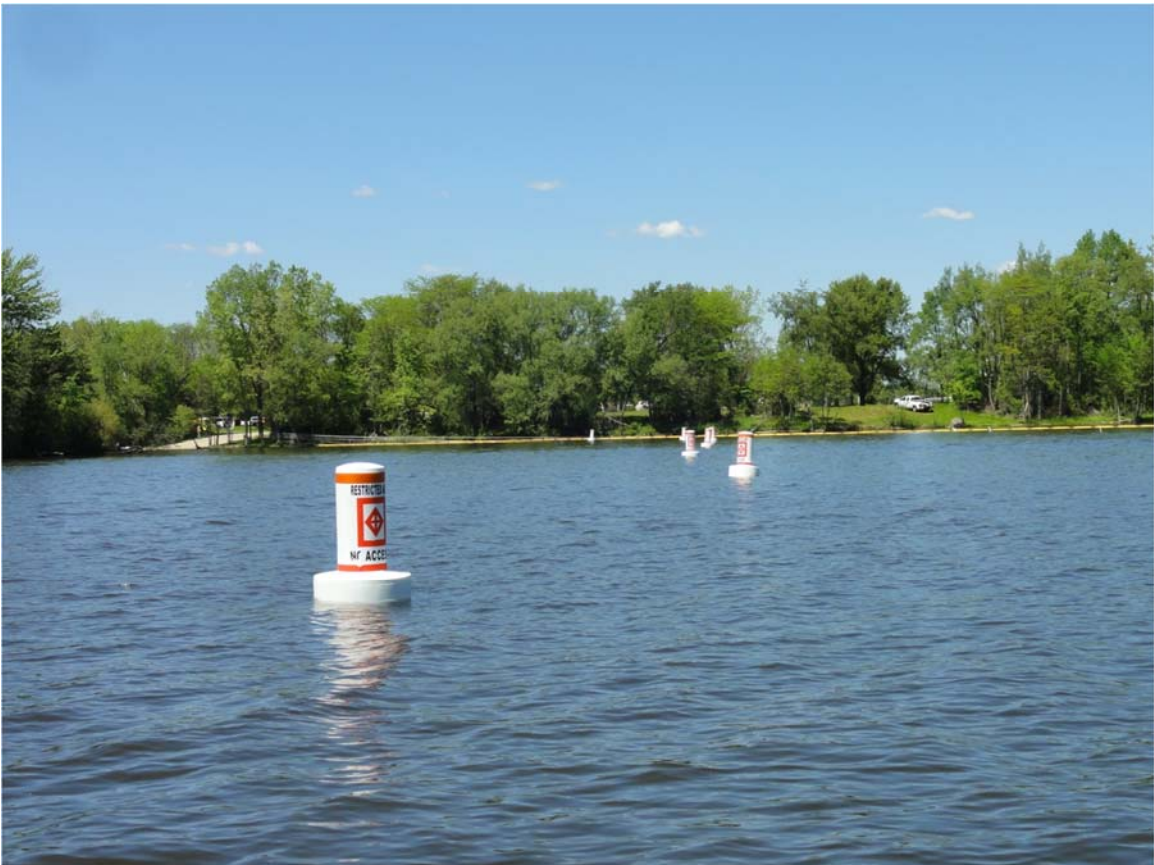
4. Can buoys deployed at E4.

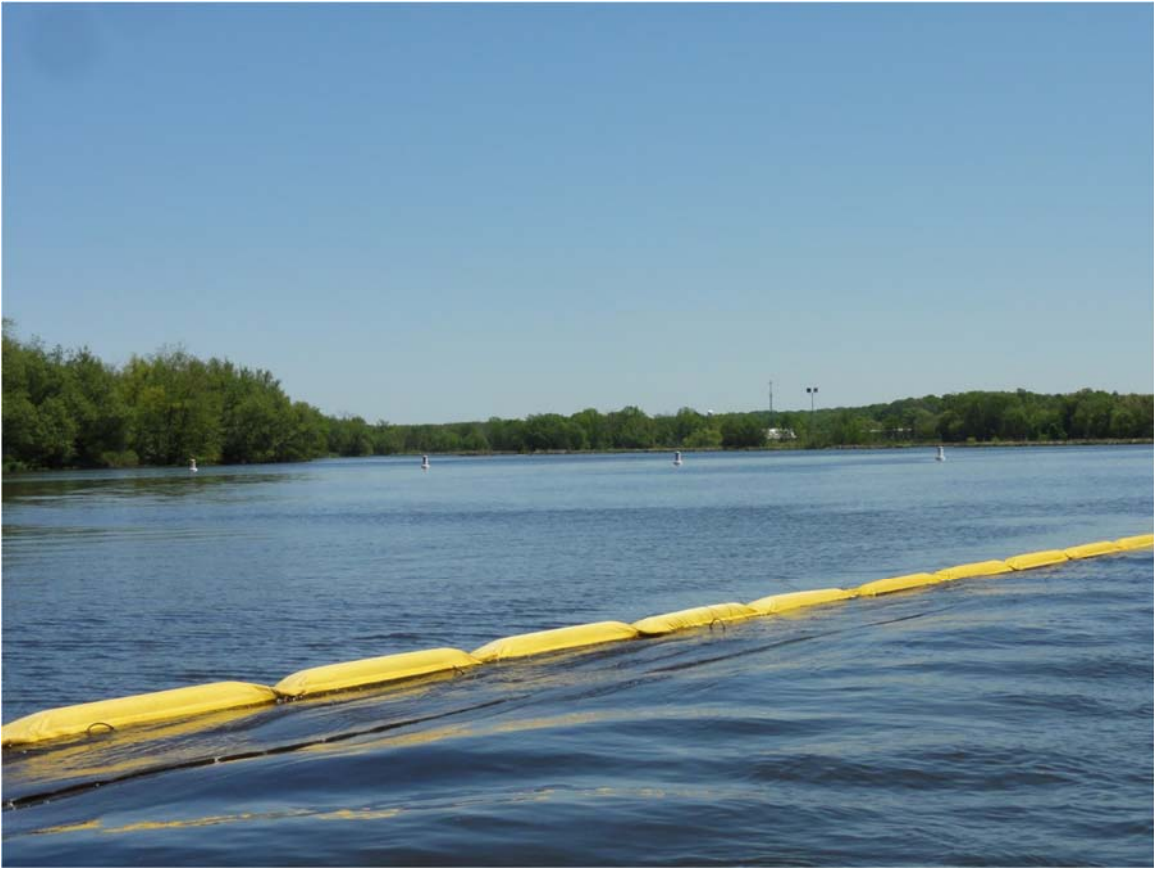
5. Buoys deployed within the Delta at E4.

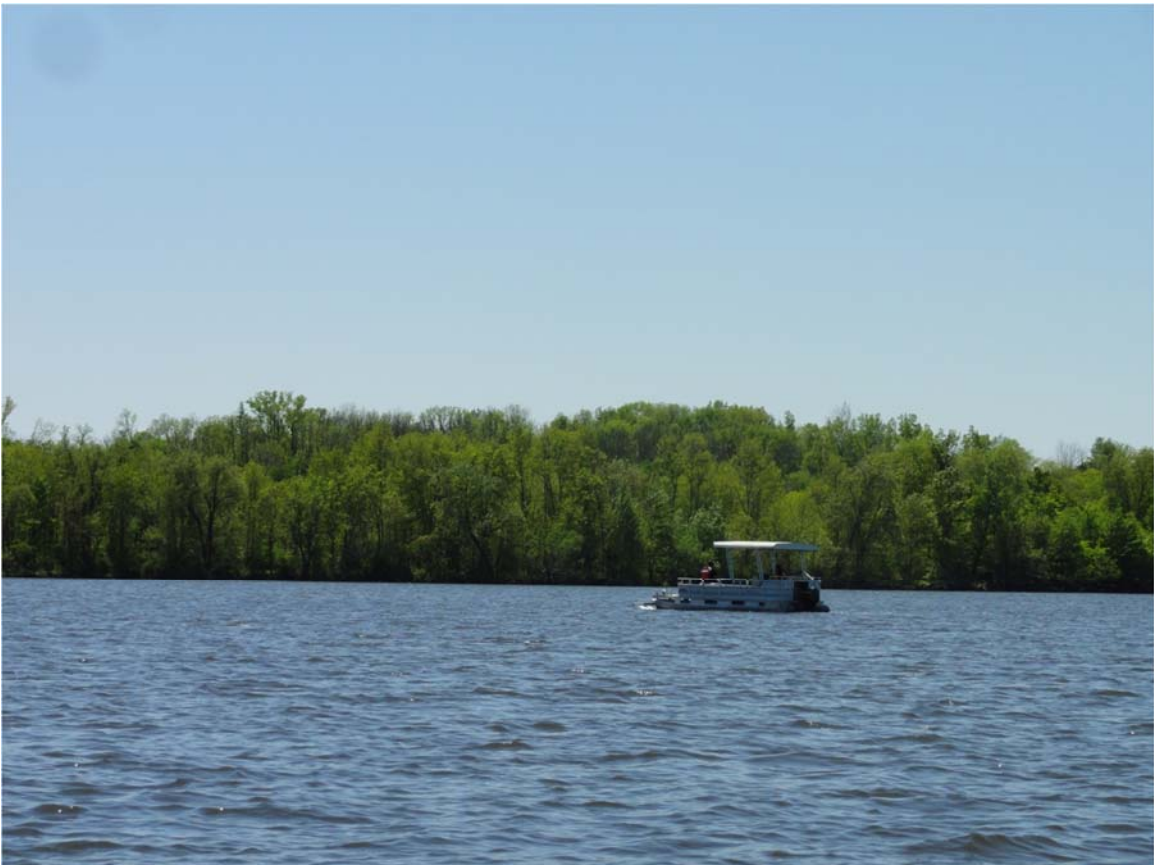
6. Sheen sweep boat operating in Lake Morrow.

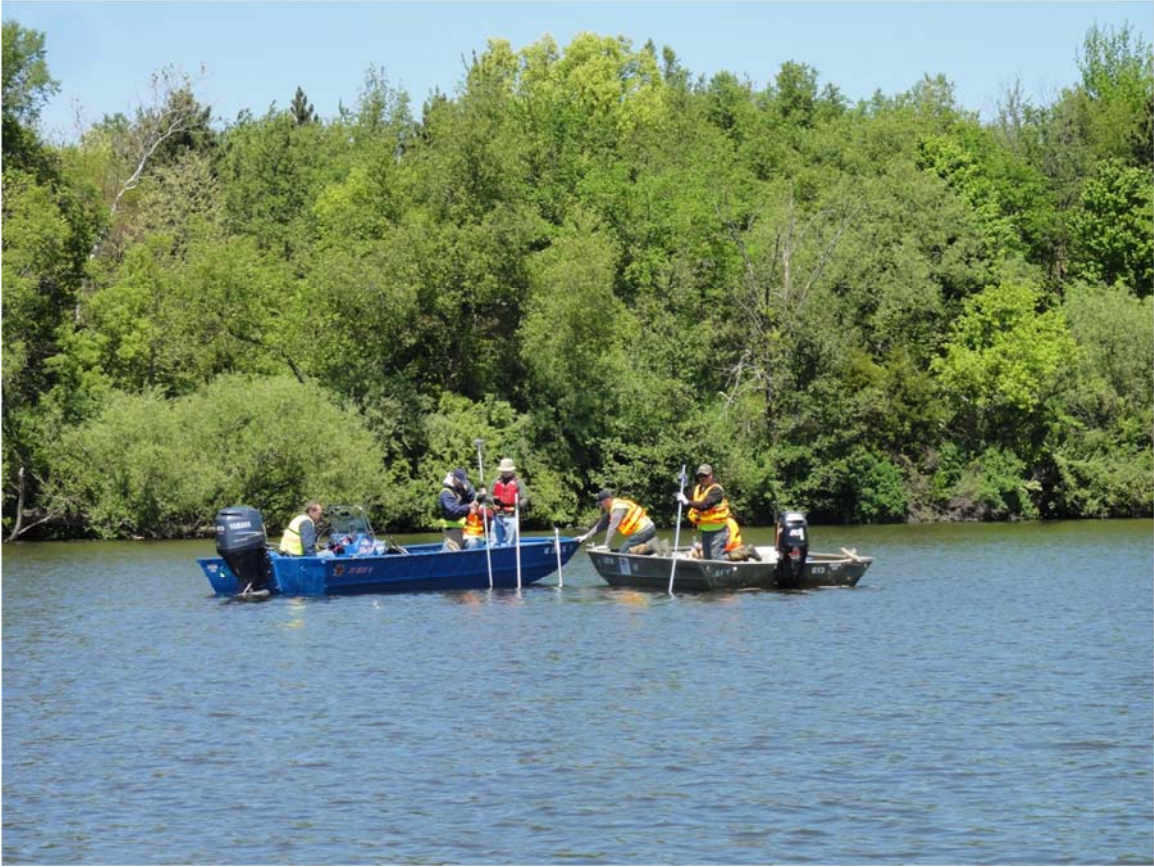
7. Morrow Lake poling crew collecting a temperature reading.

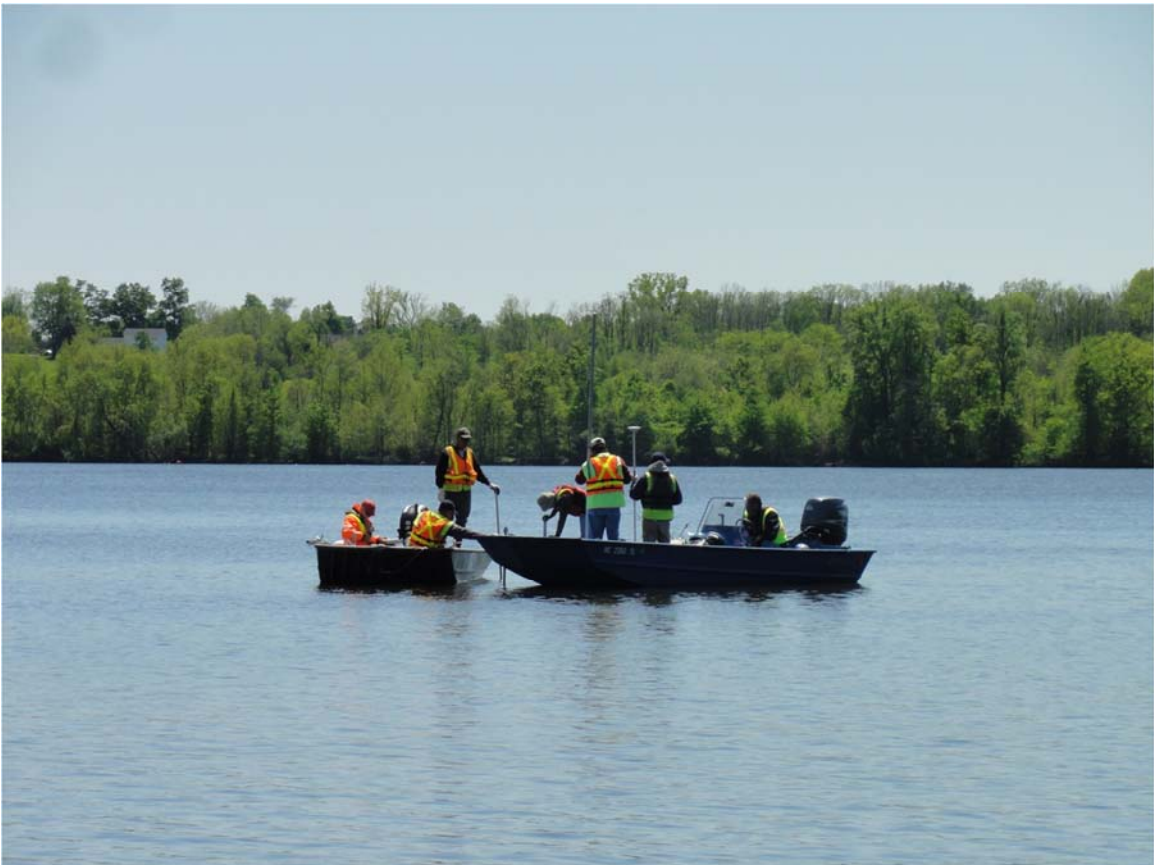
8. Morrow Lake poling crew.

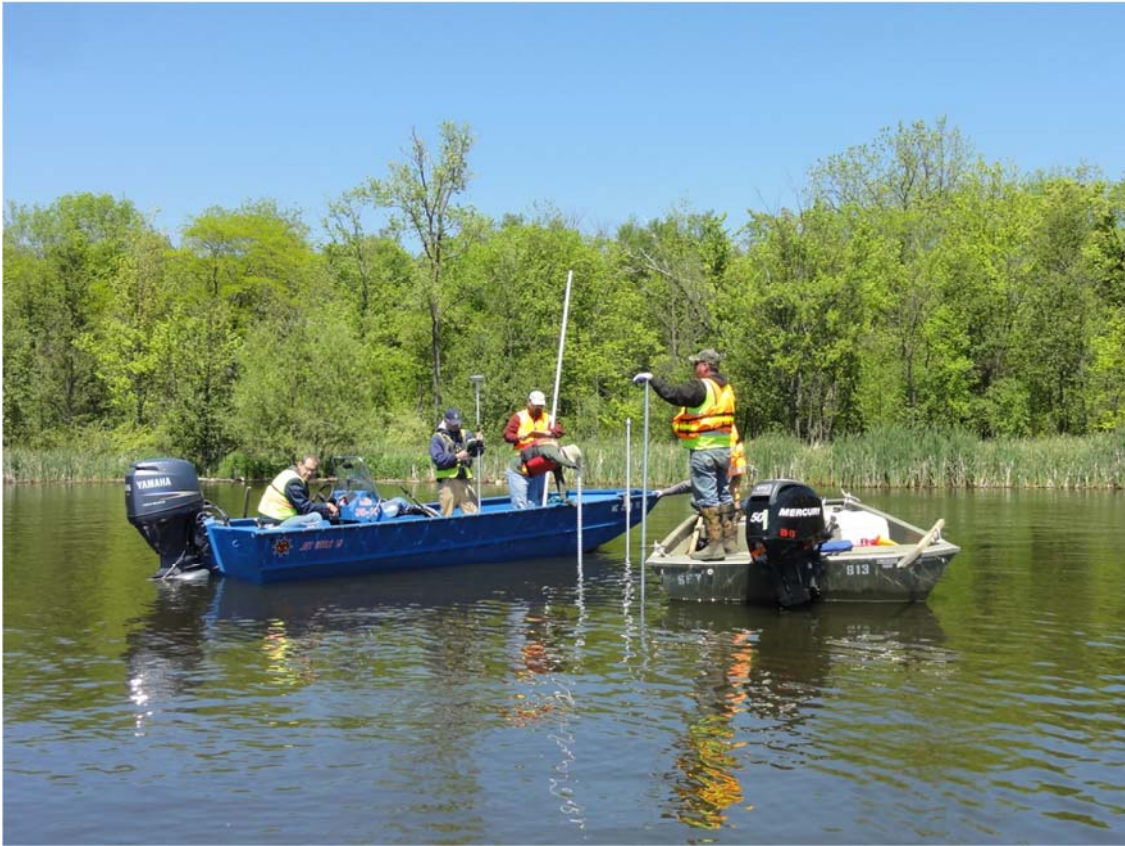
9. Morrow Lake poling crew.

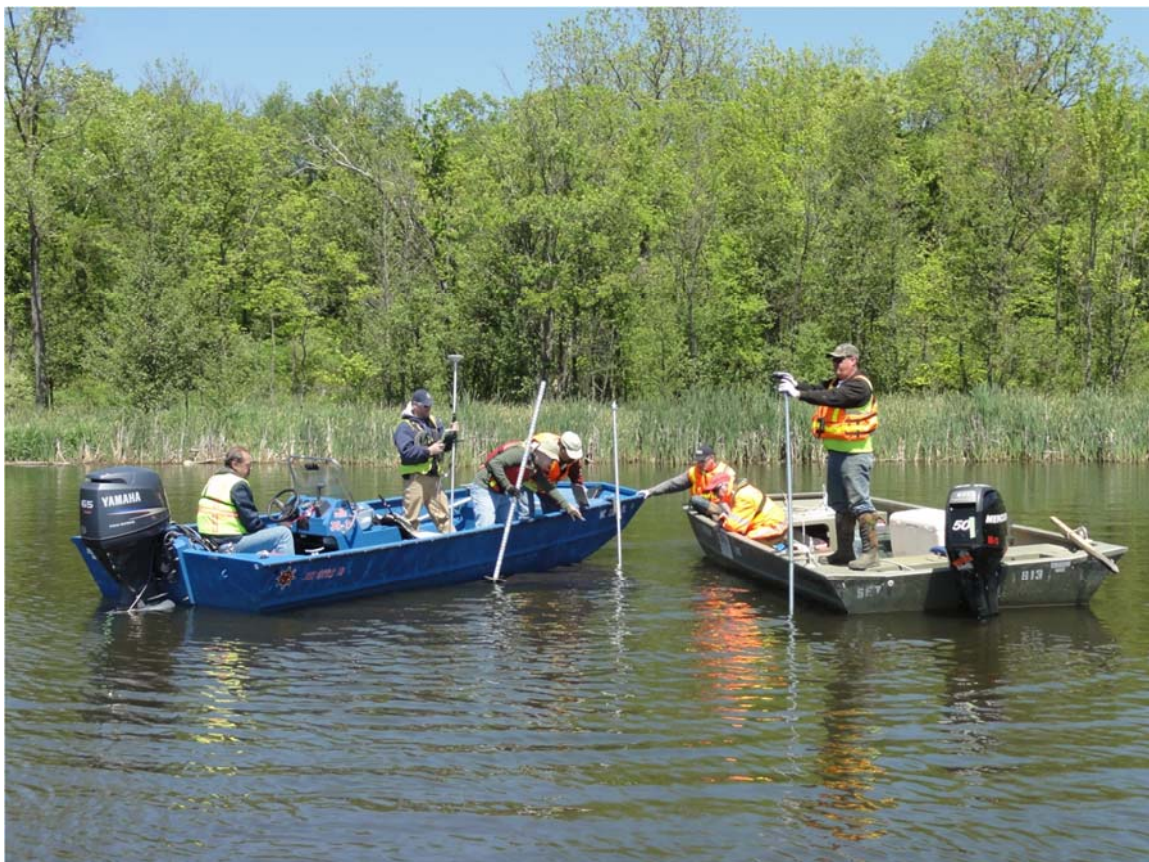
10. Morrow Lake poling crew.

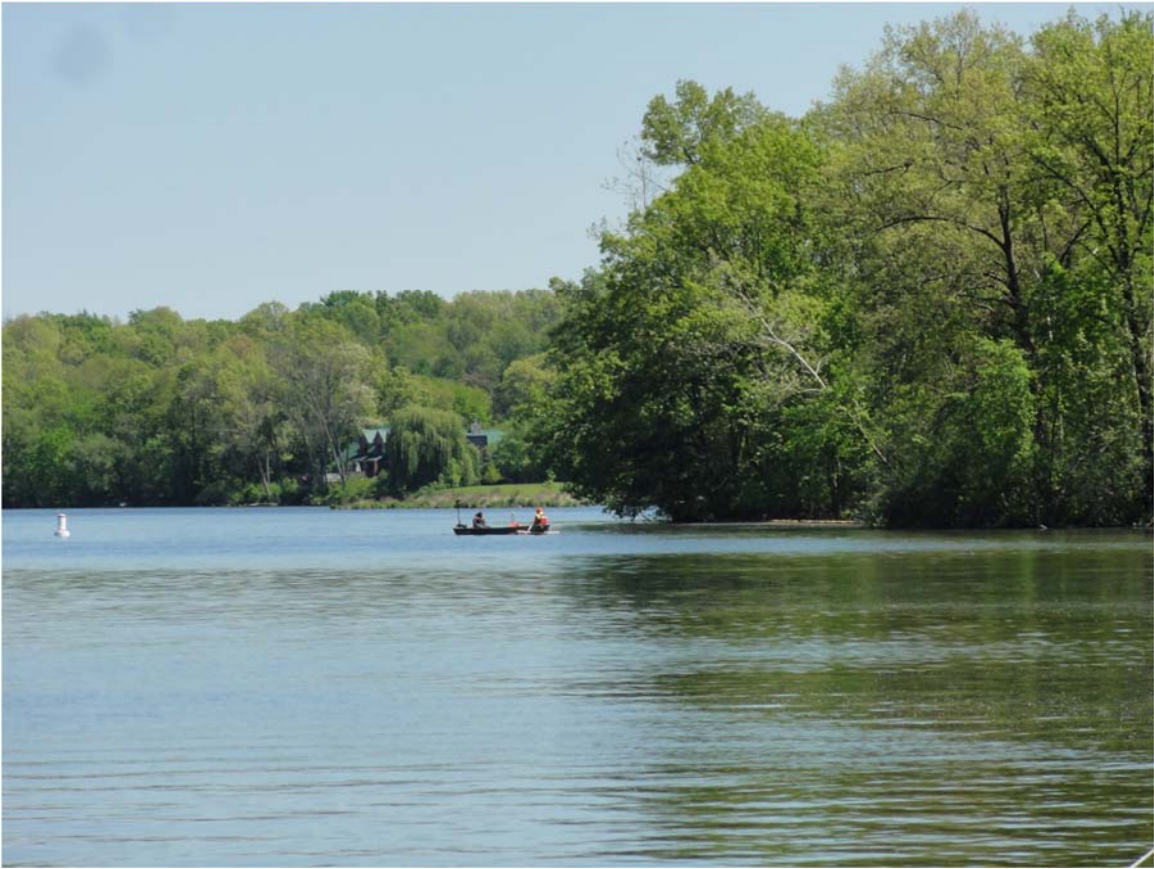
11. Sheen sweep boat observed on the Delta side of E4 control point.

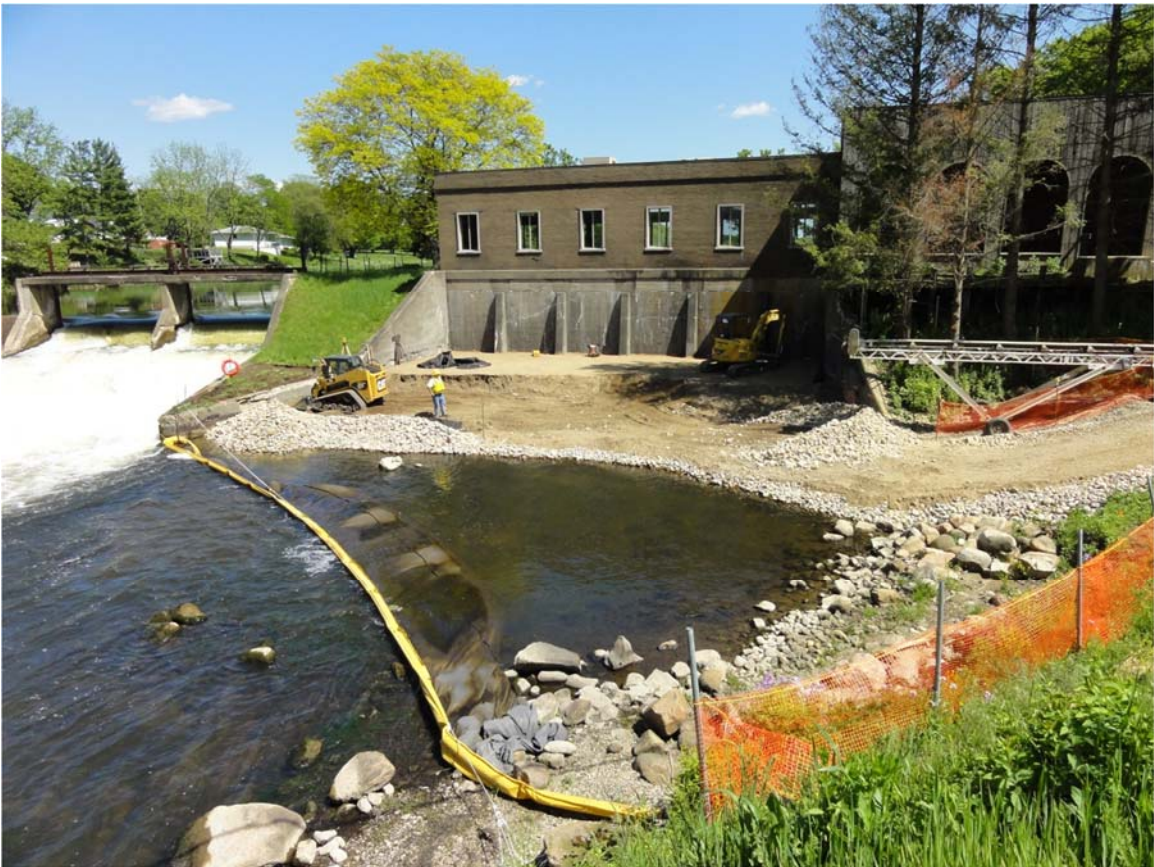
12. Ceresco Dam legacy work continued.

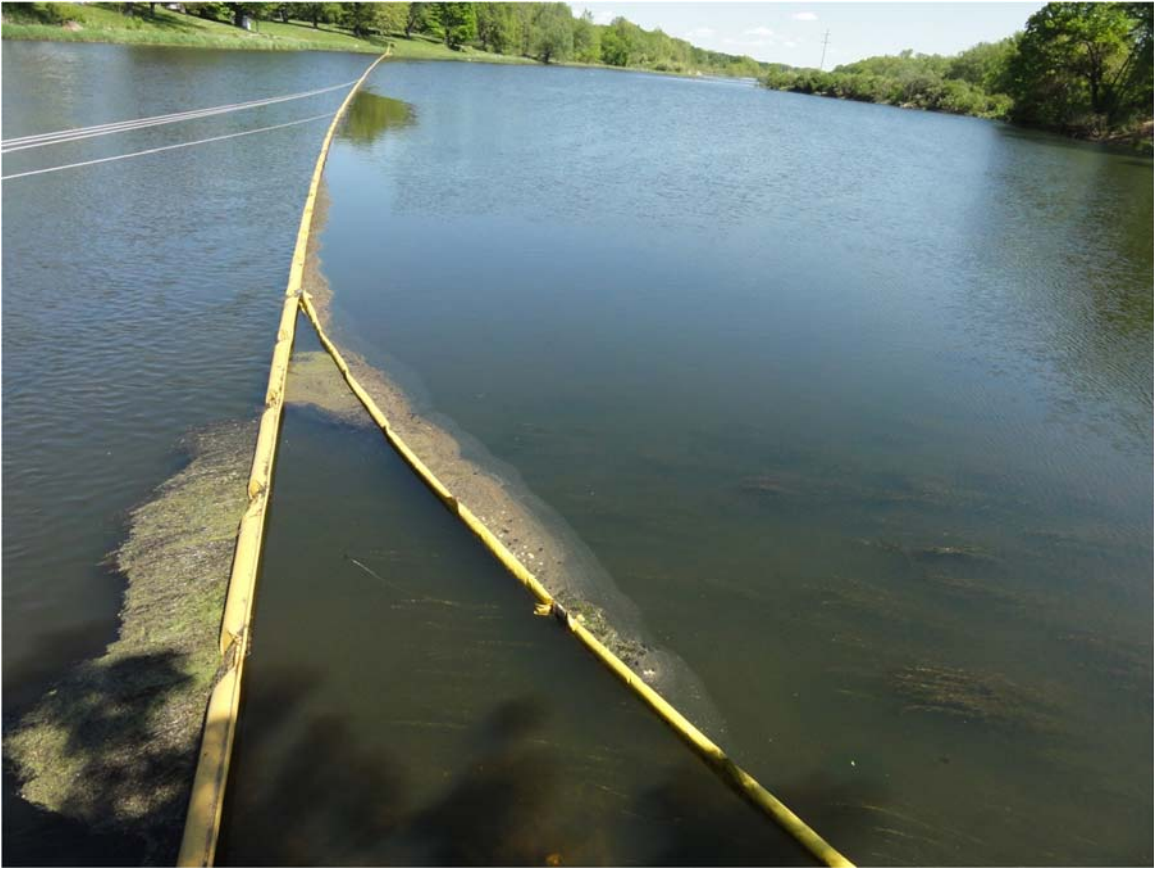
13. Ceresco Dam control point.

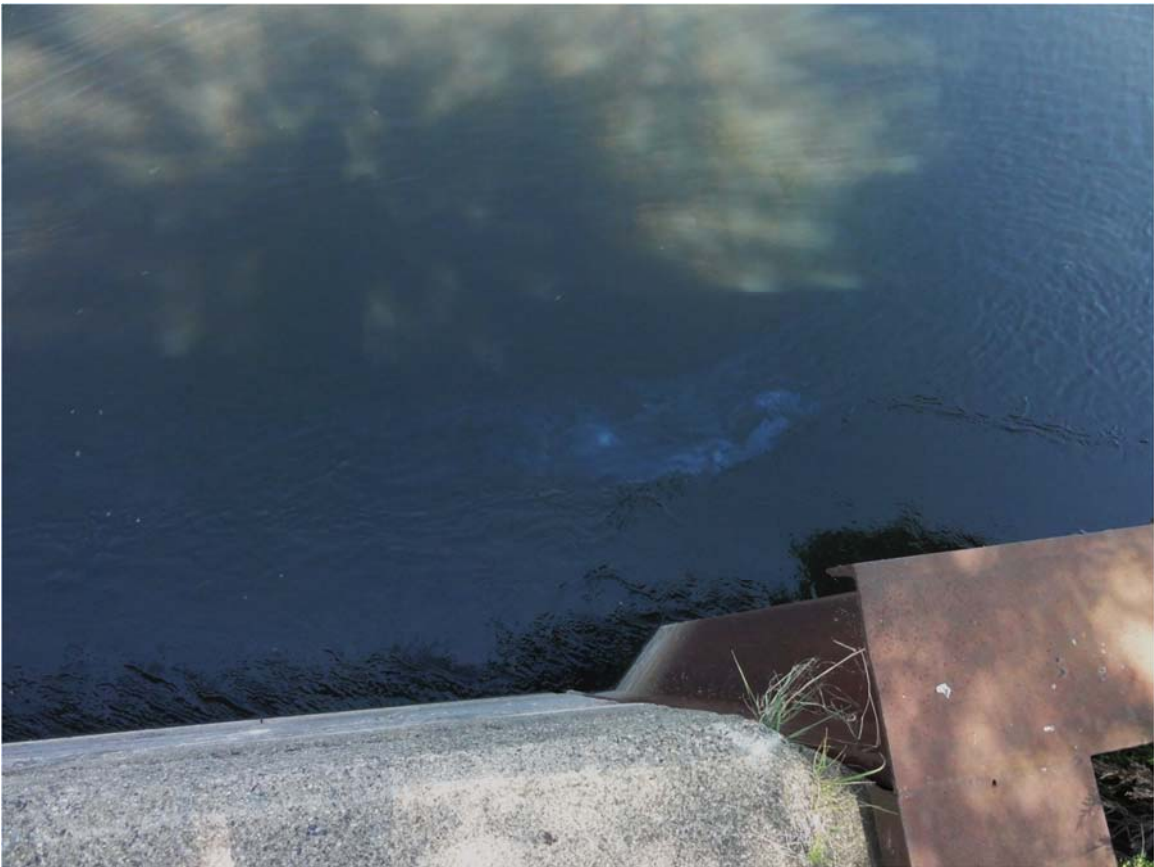
14. Ceresco Dam sheen observed bubbling up and going over dam.

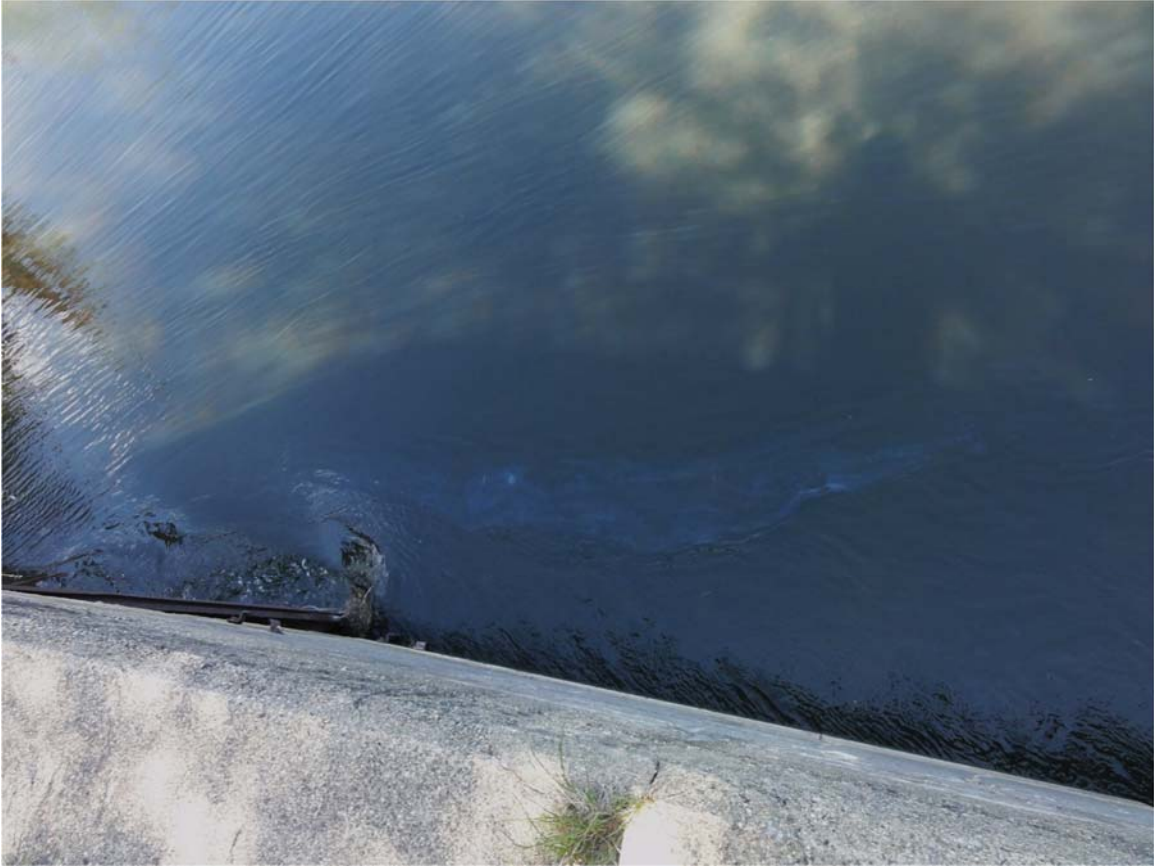
15. Ceresco Dam sheen observed bubbling up and going over dam.

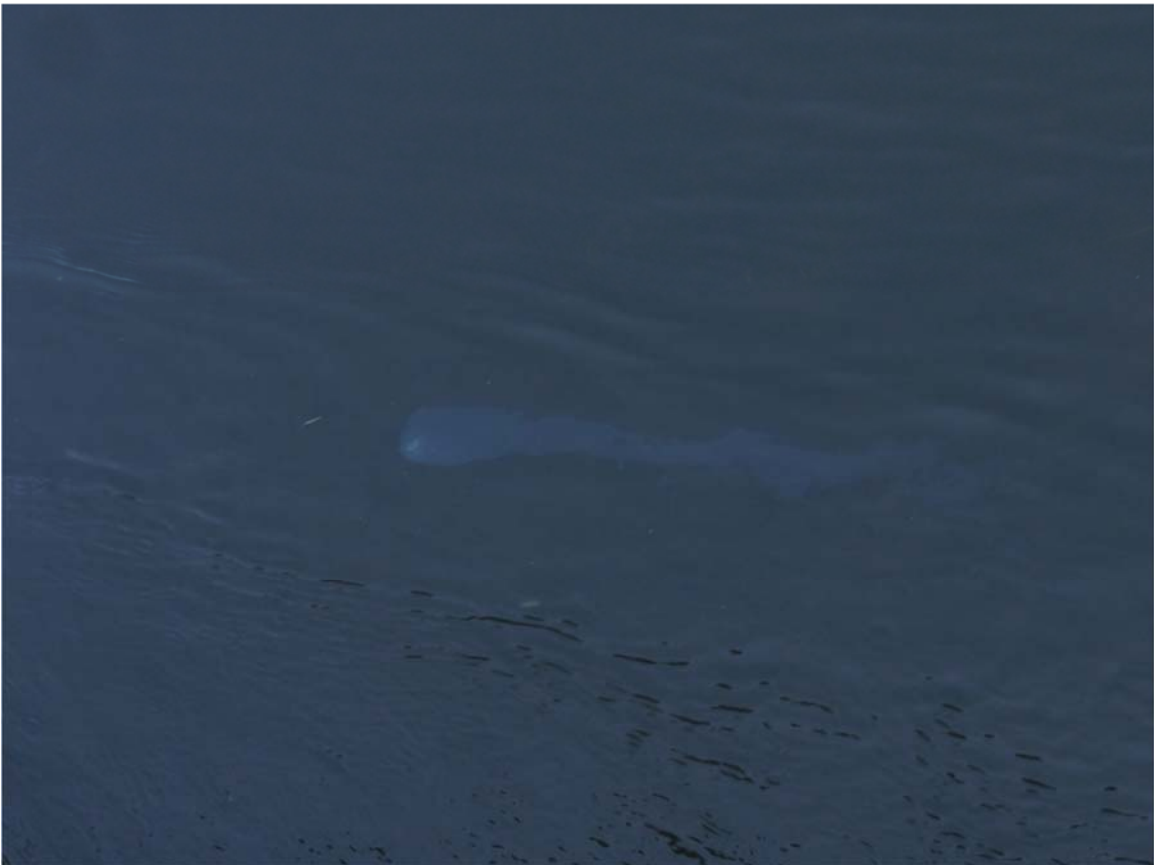
16. Ceresco Dam sheen observed bubbling up and going over dam.

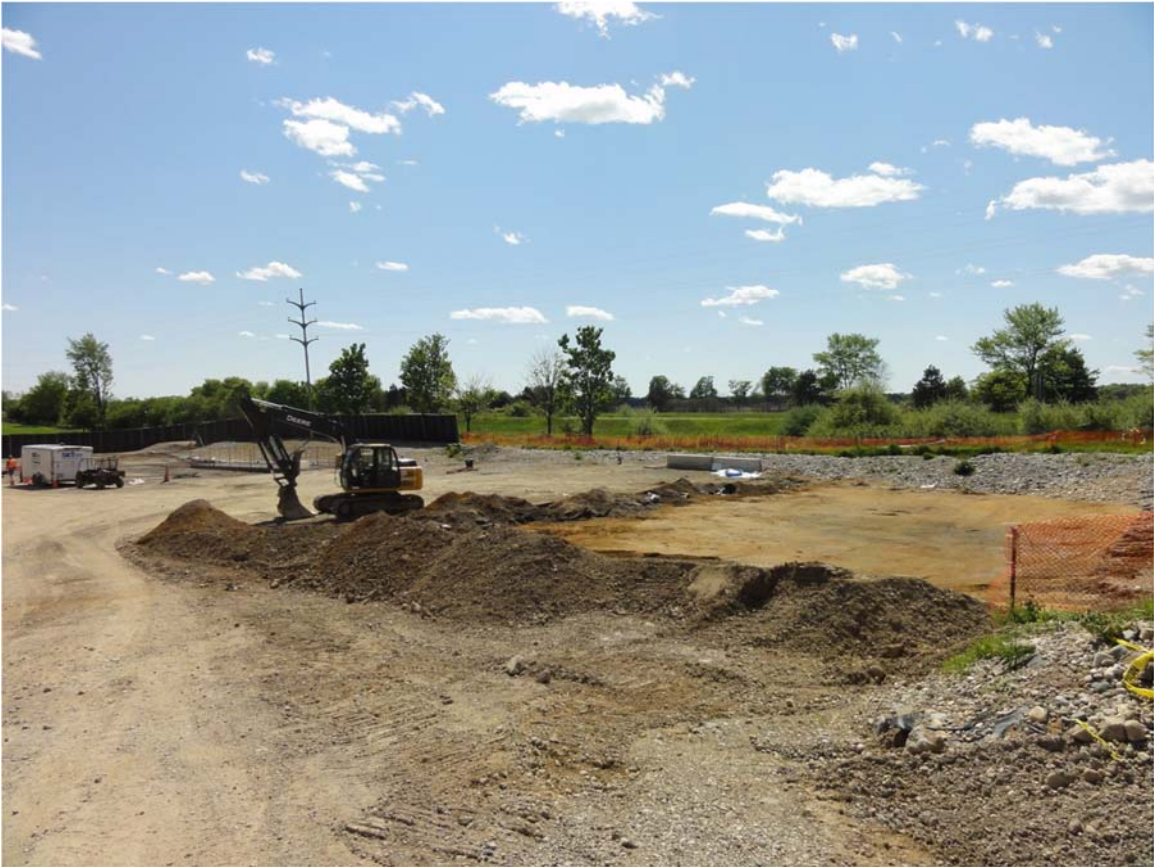
17. Frac-Tank City footprint reduction work continued.

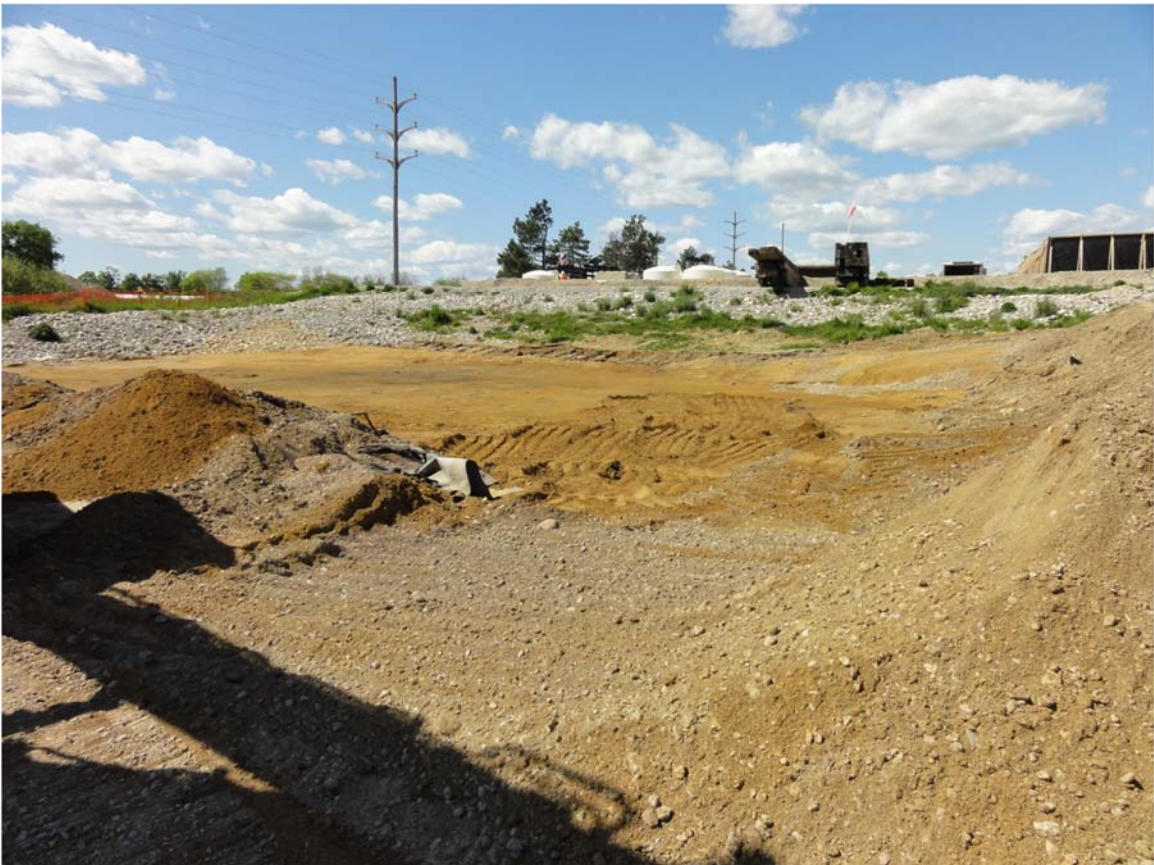
18. Frac-Tank City footprint reduction work continued.

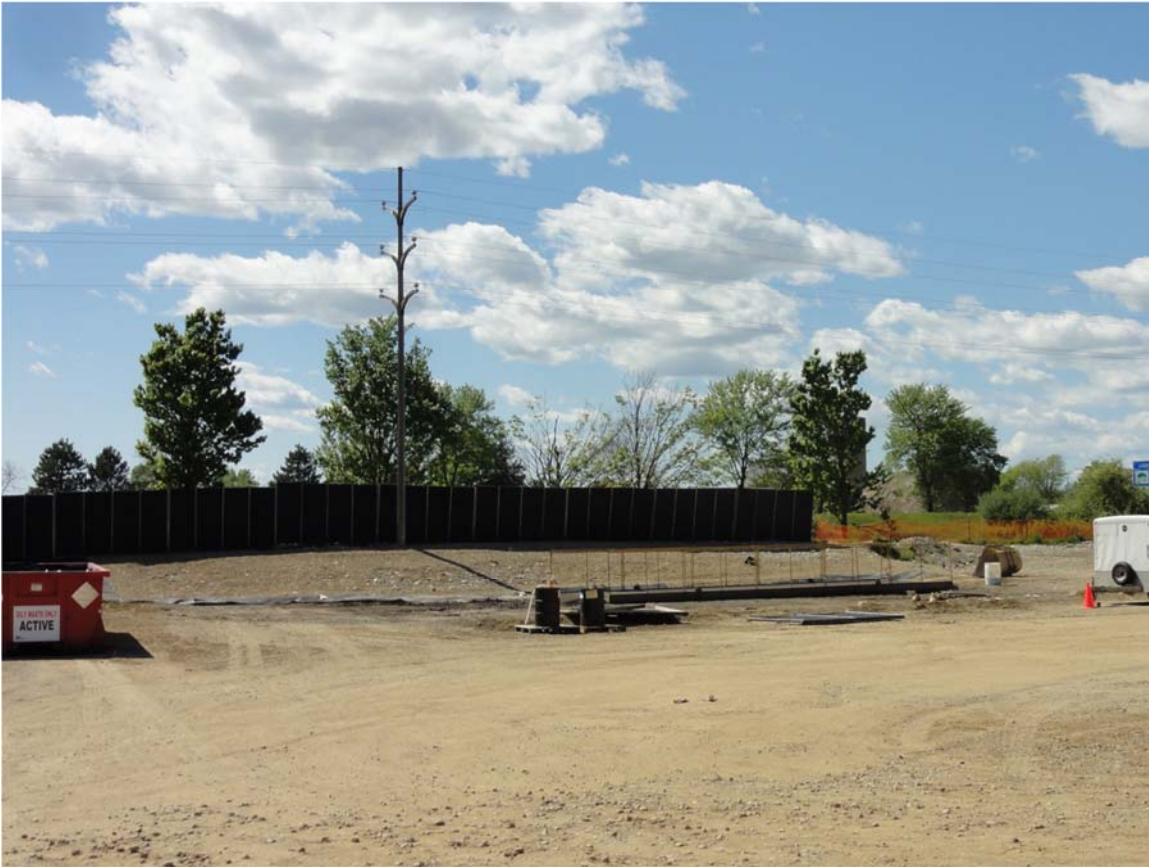
19. Frac-Tank City footprint reduction work continued.

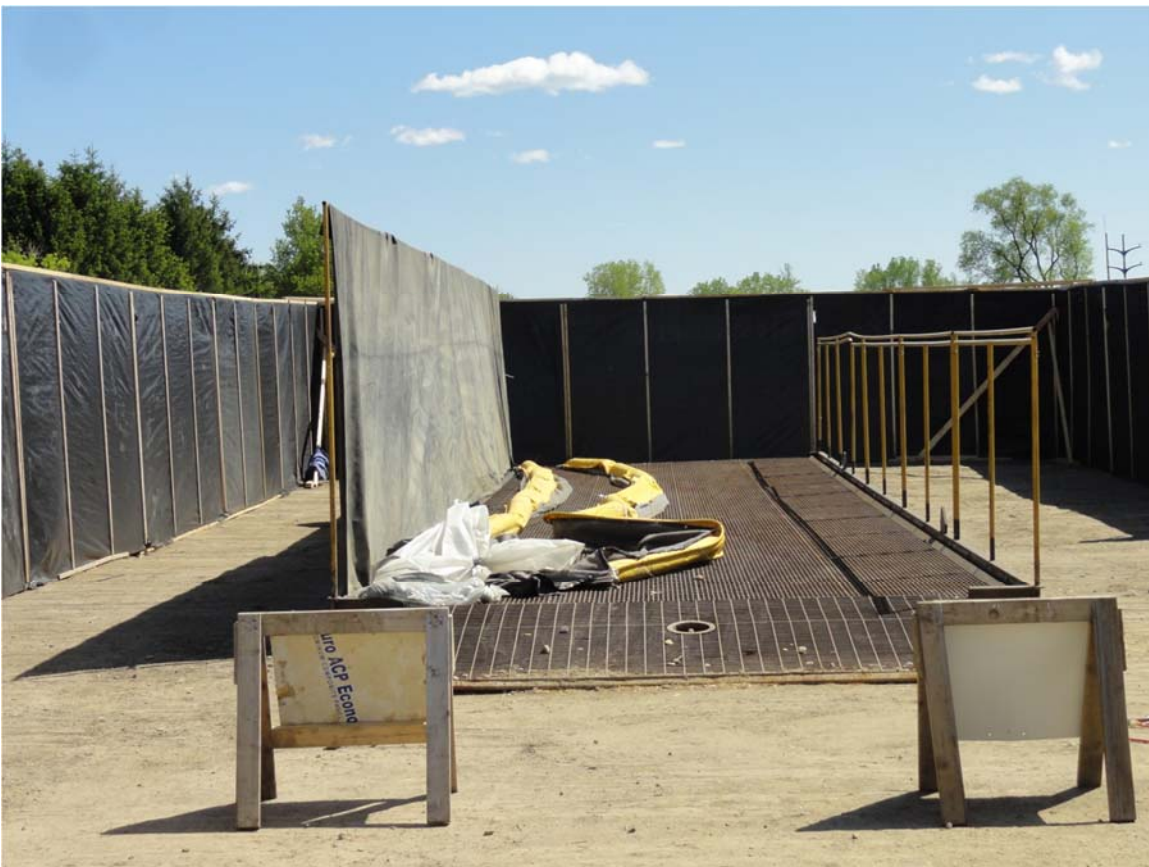
20. Frac-Tank City relocated decon pad.

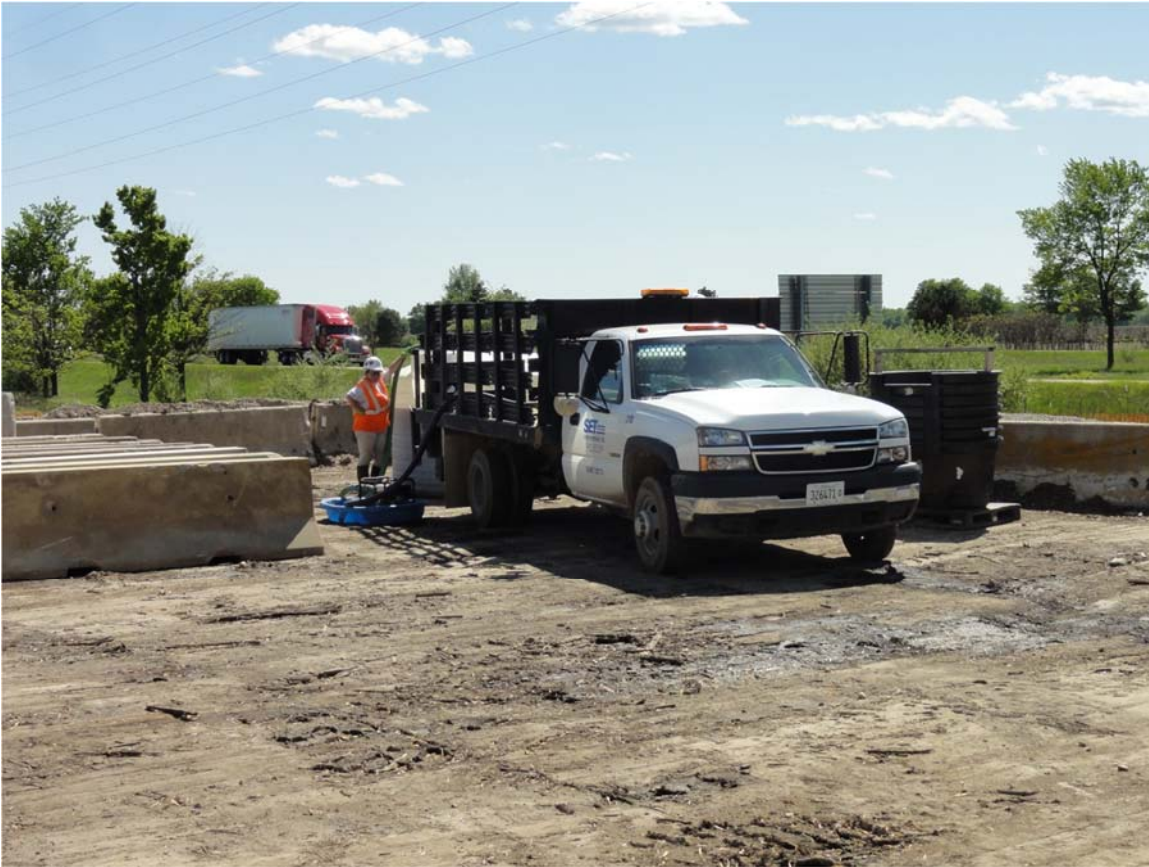
21. Frac-Tank City observed crew transferring water in poly tanks.

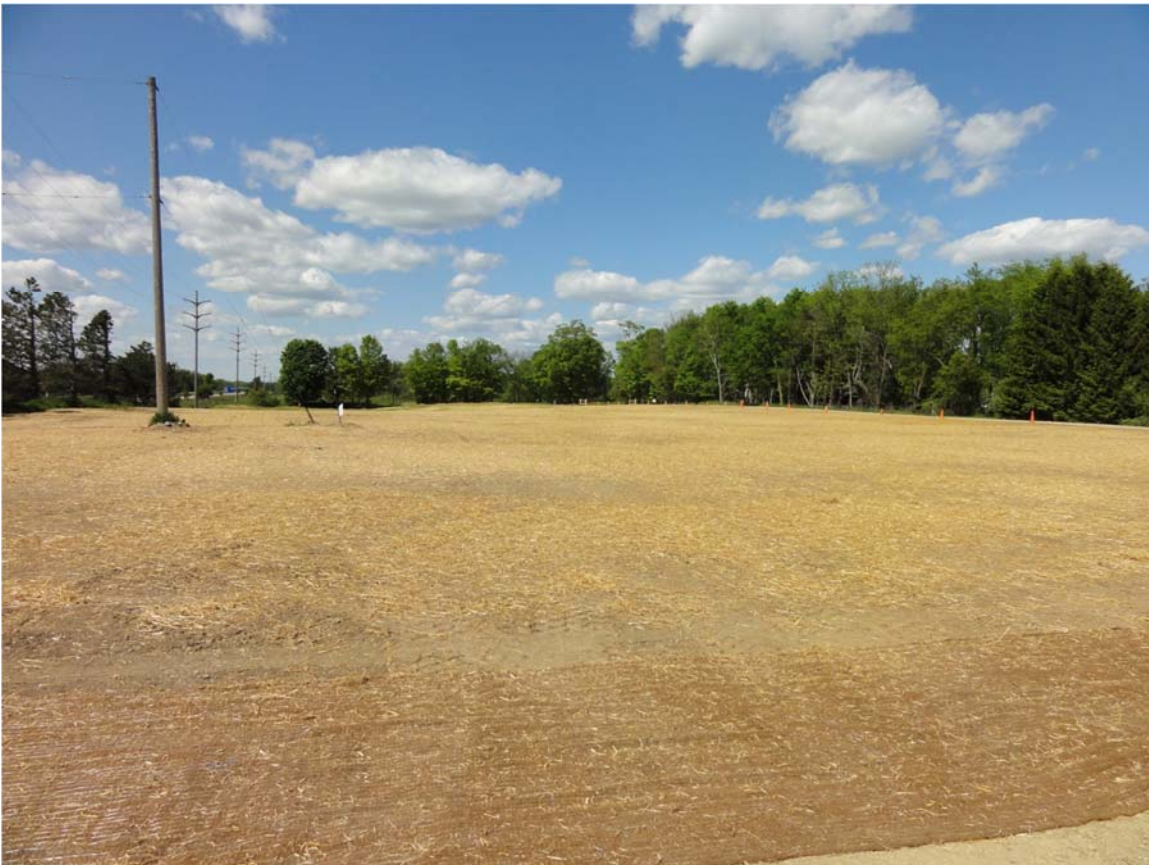
22. Frac-Tank City footprint reduction work continued.
